# Comparative Study of Mechanical Performance of AlCrSiN Coating Deposited on WC-Co and cBN Hard Substrates

**Abstract:** The objective of this study is to explore and compare the mechanical response of AlCrSiN coatings deposited on two different substrates, namely, WC-Co and cBN. Nano-indentation was used to measure the hardness and elastic modulus of the coatings, and micro-indentation was used for observing the contact damage under Hertzian contact with monotonic and cyclic (fatigue) loads. Microscratch and contact damage tests were also used to evaluate the strength of adhesion between the AlCrSiN coatings and the two substrates under progressive and constant loads, respectively. The surface damages induced via different mechanical tests were observed using scanning electron microscopy (SEM). A focused ion beam (FIB) was used to produce a cross-section of the coating–substrate system in order to further detect the mode and extent of failure that was induced. The results show that the AlCrSiN coating deposited on the WC-Co substrate performed better in regard to adhesion strength and contact damage response than the same coating deposited on the cBN substrate; this is attribute

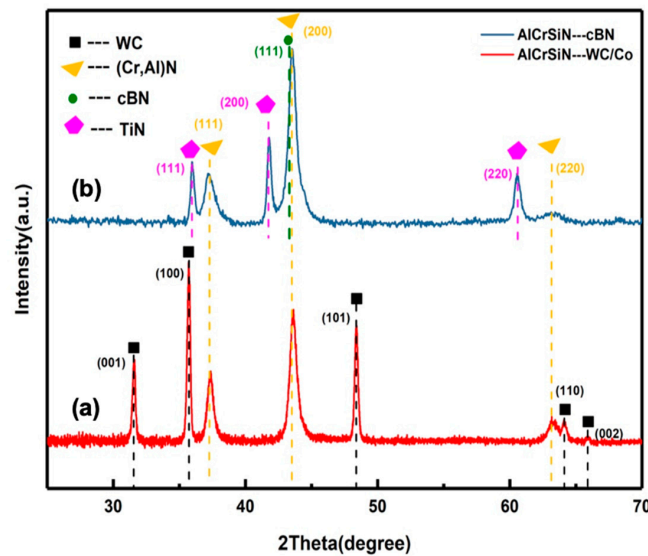
**Figure 1.** XRD patterns of AlCrSiN coatings deposited on (a) WC-Co and (b) cBN substrates. The coatings present a (Cr,Al)N crystallographic phase.

To confirm crystallographic structure and composition, XRD patterns were created and are presented in Figure 1. The phase detected for the coatings on both substrates was (Cr,Al)N solid solution, which was the main phase of the AlCrSiN coating. The (111), (200), and (220) of peaks were shifted about 0.2 degrees due to the lattice expansion produced by the substitution of Cr atoms with Al atoms [31,32]. The WC-Co substrate was also detected, as shown in Figure 1a. In Figure 1b, indexing of the cBN substrate is also presented. The binder phase TiN of the cBN substrate was clearly identified as a cubic phase. The diffraction peak at  $42.6^\circ$  was assigned to the face-centered cubic cBN [33].

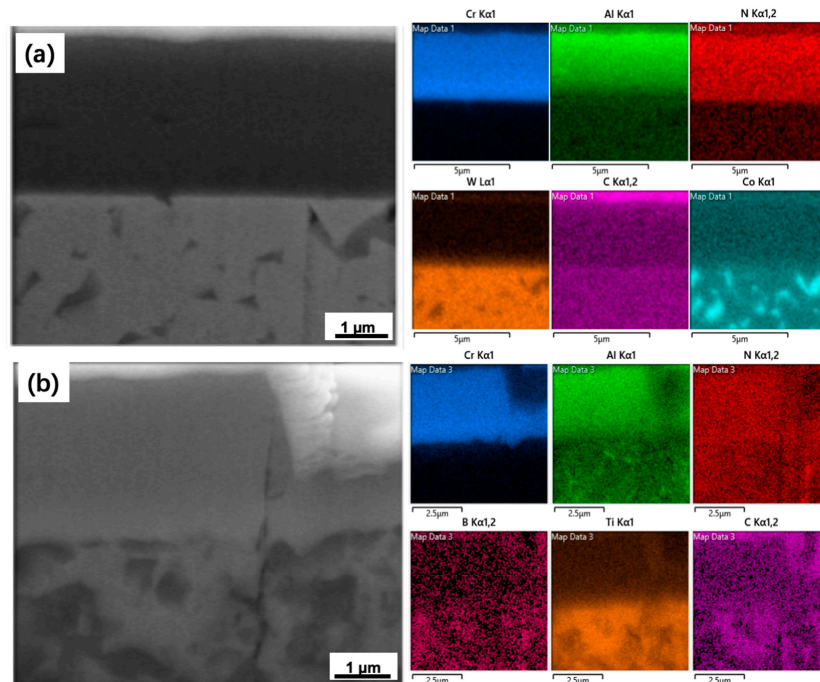
**Figure 2.** SEM micrograph of the cross-section and the EDX composition maps for corresponding areas. (a) AlCrSiN coating deposited on WC-Co substrate, (b) AlCrSiN coating deposited on cBN substrate together with the platinum layer to avoid the waterfall effect during milling procedure, and the crack in the coating and substrate was caused by the scratch test.

The deposited AlCrSiN coatings were uniform and dense both on WC-Co and cBN substrates, as seen in Figure 2a,b. Based on the EDX composition maps, elements of chromium (Cr), aluminum (Al), and nitrogen (N) were detected in the coatings. Elements of wolfram (W), cobalt (Co), titanium (Ti), boron (B), and nitrogen (N) were detected on the substrates. The results are consistent with the compositions of coatings and substrates.

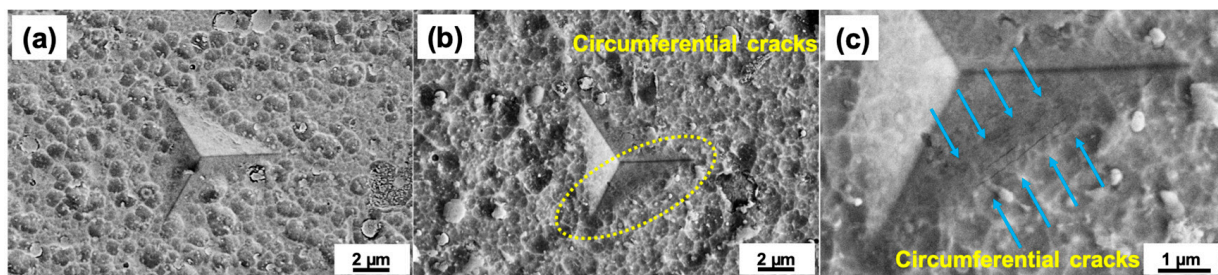
**Figure 3.** SEM images of nano-indentation, (a) AlCrSiN coating deposited on WC-Co substrate, (b) AlCrSiN coating deposited on cBN substrate, (c) magnification of the circumferential cracks highlighted with dotted circle on the image (b).

The results of nano-indentation are presented in Table 3, and the images of nano-indentation imprints are presented in Figure 3. According to Table 3, the AlCrSiN coatings exhibited similar values when deposited on different substrates, WC-Co and cBN, which means the mechanical properties of the coatings were not altered by the substrates. Some circumferential cracks, shown in Figure 3c, appeared at the inner edge of the nano-indentation and indicated that the cracking resistance of the AlCrSiN coating deposited on the cBN substrate may be lower than the sample with the WC-Co substrate, probably due to the higher stiffness of the substrate.

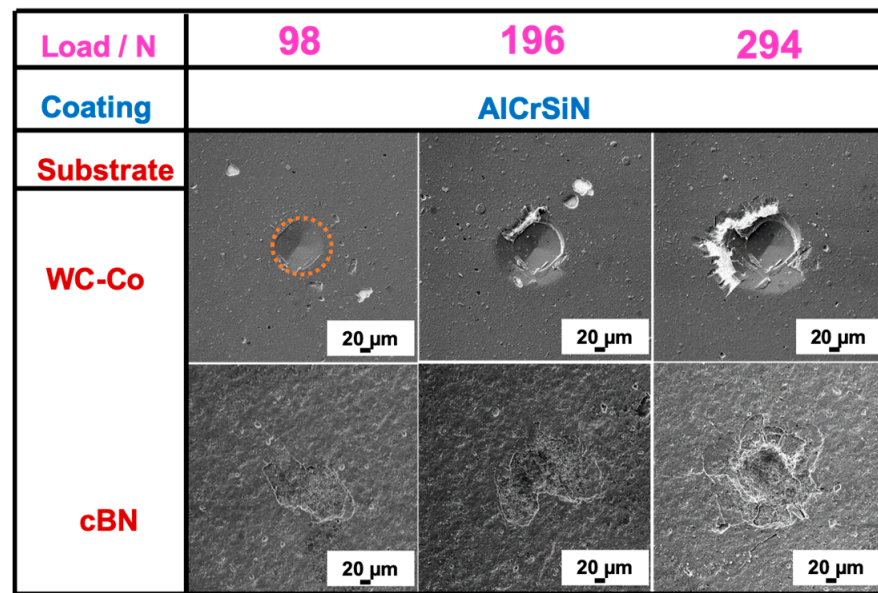
**Figure 5.** SEM images of the contact damage tests of AlCrSiN coatings at 98 N, 196 N, and 294 N with a Rockwell C tip for both substrates. Contact area of the coating on WC-Co for 98 N is indicated.

Figure 5 presents the SEM images after the contact damage tests at a series of normal loads of 98 N, 196 N, and 294 N. For the sample of AlCrSiN coating deposited on the WC-Co substrate, the coating does not show any cracking. At loads of 196 N and higher, radial cracking and delamination can be observed. In the case of the cBN substrate, delamination is clearly present even for the smaller loads. As the load increases, more spalling of the coating is observed, similar to previous research on similar materials [34,45,46].

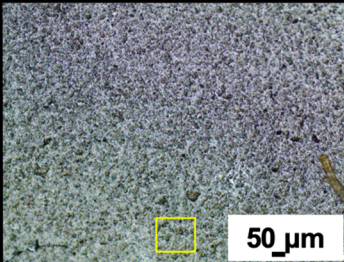
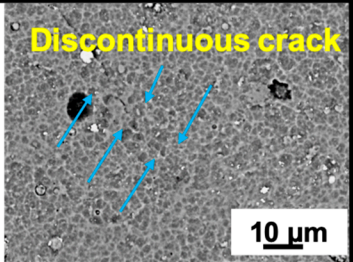
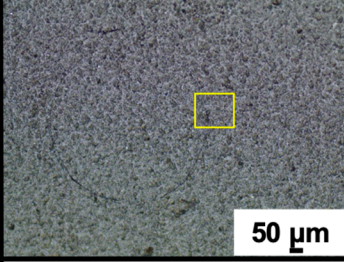
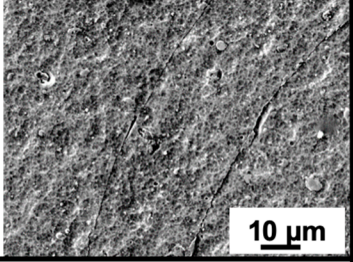
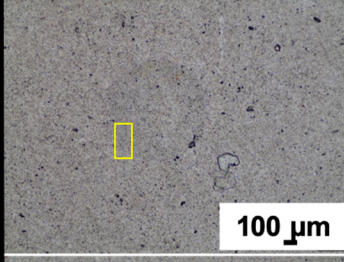
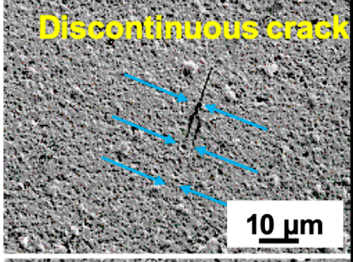
Figure 7. SEM images of damage features of AlCrSiN coatings deposited on WC-Co and cBN substrates induced via spherical indentation under different loads (2000 N, 3000 N, 5000 N, and 6000 N).

Both materials were indented using a spherical indenter with a monotonic load and cyclic load to investigate the contact mechanical response under different conditions [47–49]. Figure 7 shows the SEM images of the damage failure induced via spherical indentation under monotonic loads. The surface of the cBN substrate sample presented discontinuous cracks under the monotonic loads of 2000 N. When the load increased up to 3000 N, the edge of the indentation formed a complete crack circle. However, for the samples deposited on the WC-Co, the discontinuous cracks and complete ring cracks appeared at larger loads of 5000 N and 6000 N, respectively, which shows the form and shape of the cracks over the load of the first damage. In agreement with previous results, the contact resistance of the coatings deposited on the WC-Co is larger than for the coatings deposited on the cBN substrates.

This lower adhesion can be partially attributed to the difference in chemical nature of each substrate. However, it is also seen that the structural integrity of the coating is also more affected when deposited on the cBN substrate under contact loadings, albeit having the same composition and intrinsic mechanical properties such as hardness and elastic modulus. In this sense, the differences in mechanical properties of the two substrates induce different contact damage responses and damage evolutions with increasing loads (as seen in Figures 7 and 8). As seen in Table 2, cBN is harder than WC-Co. If the contact
