Article

Corrosion Behavior in Volcanic Soils: In Search of Candidate Materials for Thermoelectric Devices

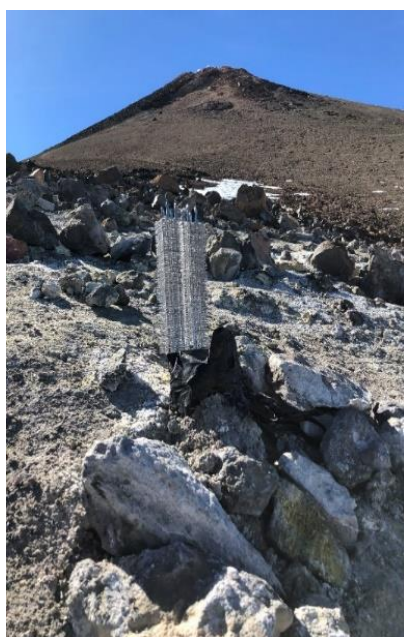
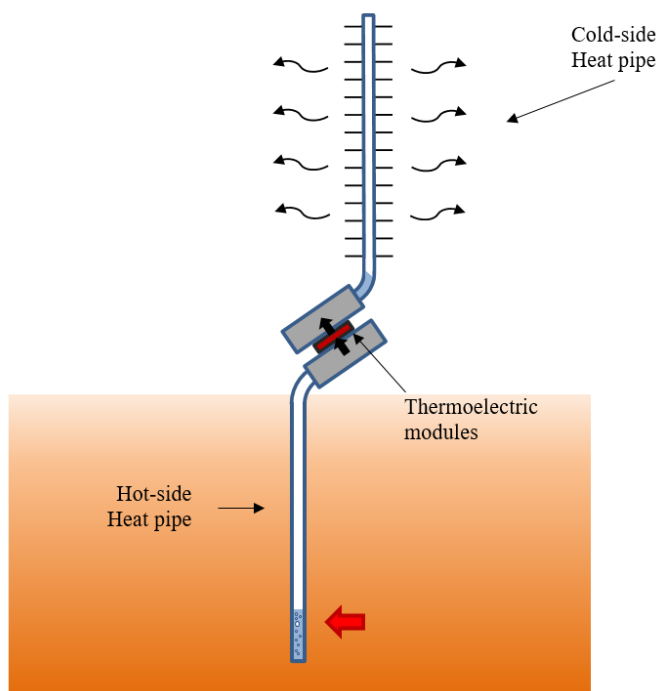
Figure 1 depicts the first prototype of thermoelectric generator installed at Teide volcano in March 2019 [12], as well as its schema of operation. This device absorbs geothermal heat thanks to eight 450 mm long grooved heat pipes made of nickel-plated copper and with water as working fluid, which are inserted in an aluminum plate. Two bismuth-telluride thermoelectric modules transform part of this heat into electricity, releasing the rest to the environment by means of a similar heat exchanger, with the only difference of including 62 aluminum fins separated 5 mm for increasing the heat exchange area.

Figure 1. First thermoelectric generator installed at Teide volcano on March 2019 and its schema of operation.

This prototype was installed at Teide volcano (Canary Islands, Spain) on March 2019, at an altitude of 3500 m, where there exist 82.5 °C fumaroles. During three days, it demonstrated the viability of thermoelectric generation from fumaroles, being able to produce between 0.32 and 0.33 W, which represents a good starting point for autonomous volcanic monitoring. However, after just three days, the monitoring of the different

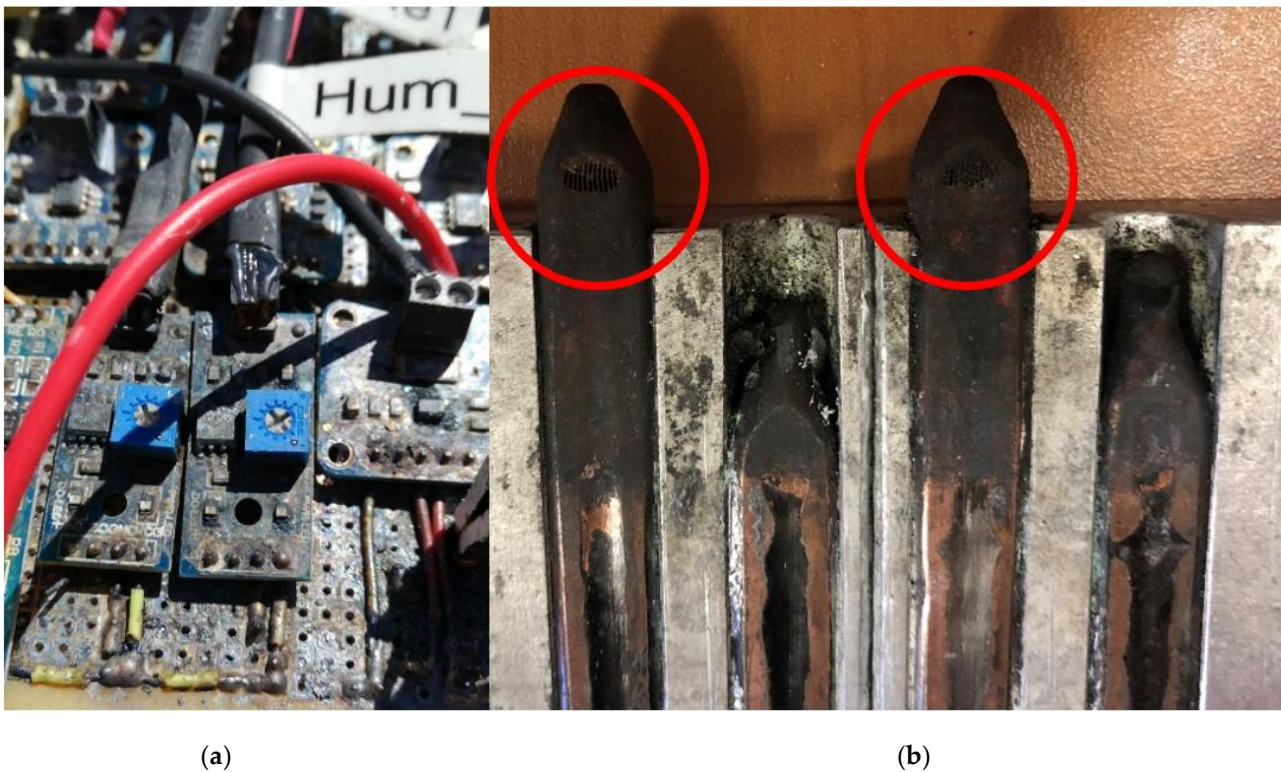
variables stopped. The examination of the prototype three weeks later reported severe corrosion of the electronic system, as depicted in Figure 2.

Figure 2. (a) Detail of the corrosion of the electronic system. (b) Detail of the perforated tubes due to corrosion.

Due to the failure, the complete prototype was taken off, and thereafter, a visual analysis of corrosion in the generator itself could be performed. This analysis showed that corrosion also affected the generator. Copper tubes were the most affected element of the generator. In fact, as depicted in Figure 2, in only one month, corrosion perforated the tubes, causing the leakage of the internal working fluid.

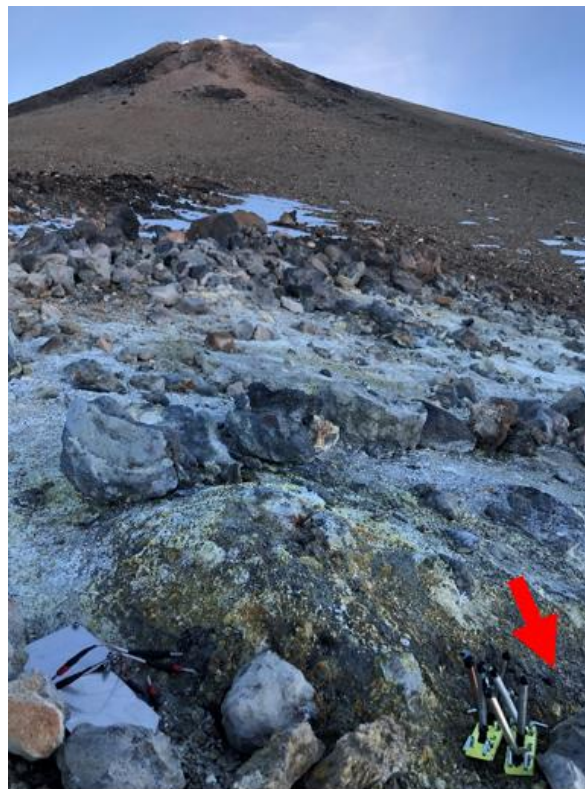
Figure 3. Location of the buried samples in the proximity a fumarole at Teide volcano.

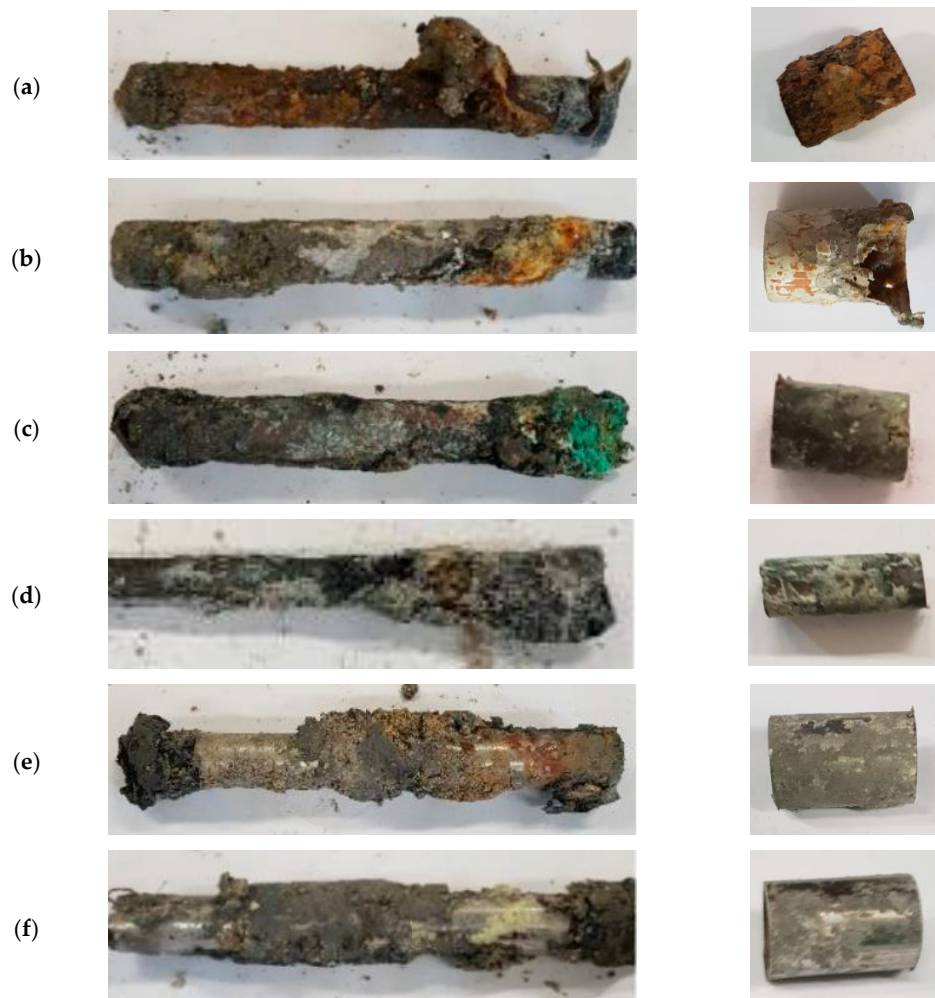
Figure 4 shows the six metal pipes after having been buried in the volcanic soil for one year, depicting the whole tube on the left and one cut that was made for the subsequent analyses on the right, before the chemical cleaning performed in accordance with standard 8407 [26].

Figure 4. Photographs of the complete tubes after the field tests and a cut that was made for the subsequent analyses. (a) Galvanized Steel. (b) Anodized Aluminum. (c) Copper. (d) Brass. (e) AISI 304 and (f) AISI 316.

As can be observed, all the samples show a high content of soil and corrosion products adhered to the interior and exterior of the tubes. When analyzed separately, the corrosion products present a different aspect. Thus, on the surface of the galvanized steel, a mixture of dark brown earths and white zinc corrosion products can be observed. In the anodized aluminum tube, a great amount of white corrosion products are detected. In addition, it is necessary to emphasize that in a zone of the tube, the corrosion has advanced from the interior achieving the tube fracture. Green and dark corrosion products mixed with earth

have adhered to the copper tube. Brass shows less corrosion products and soil adhered to its surface. Finally, in the stainless steels 304 and 316 metallic zones without apparent corrosive damage can be observed.

Based on the visual analysis, the stainless steels are apparently the least corroded material. Nonetheless, it is necessary to perform more analyses in order to determine the degradation grade of each material, which is performed in the following subsections.

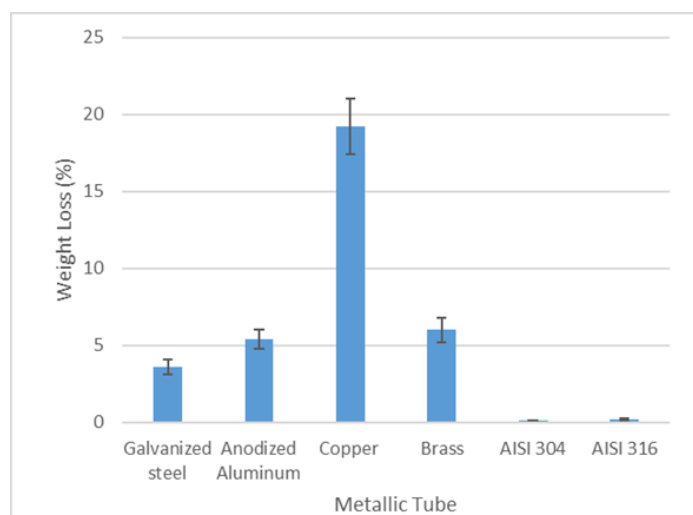
The initial analysis that was performed was the determination of weight loss, which was carried out with the whole samples (not cut). The results of weight variation after the field test are shown in Figure 5. As can be seen, copper is, by far, the material that has suffered the highest weight loss (19.25%) followed by brass (6%). The anodized aluminum and the galvanized steel have also undergone an important weight loss of 5.4% and 3.6%, respectively, while the stainless steels have not experienced any weight loss.

Figure 5. Representation of the weight loss of the metallic samples.

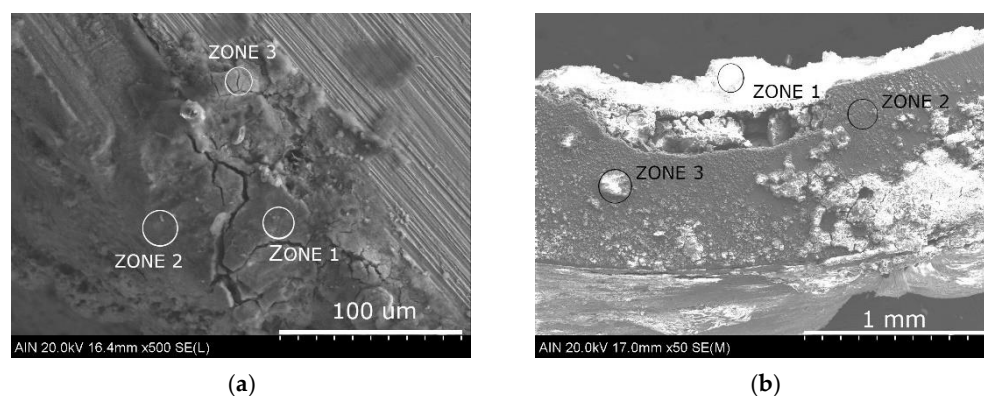
The microanalyses carried out on the galvanized steel sample, as shown in Table 2, indicate the formation of mainly iron oxides. Titanium, silicon, sulphur and aluminum from the volcanic soil have also been detected, but in a lesser extent.

Figure 7. SEM images (a) in galvanized steel sample, (b) in anodized aluminum sample.

In the case of aluminum, the results vary depending on the zone of study as depicted in Table 2 and Figure 7. Thus, on the inner side of the aluminum sample (zone 1), a layer of silicates and sulphides from the soil can be seen. In zone 2, it can be seen how the corrosive attack progresses through the reaction of the soil components with the aluminum. In contrast, the anodizing layer of the aluminum sample has not suffered any corrosive damage and good adhesion to the aluminum is observed.

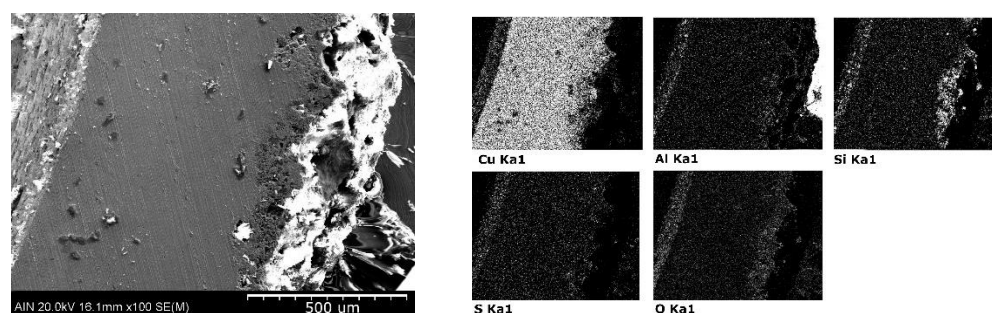
Figure 8 shows how the copper sample has undergone intense corrosive damage to the entire outer surface. More specifically, the results indicate that the copper reacts with the soil to form aluminum silicates and copper oxides.

Figure 8. Elemental mapping: microanalysis by SEM-EDX performed of copper sample.

The copper sample has suffered a severe corrosive attack resulting in an excessive loss of weight and thickness. The high content in sulphur compounds and low pH have led to the formation of abundant corrosion products such as Cu_2O and CuS . The high corrosivity of this type of volcanic soils is mainly associated with the reactions of the native sulphur with the soil moisture producing hydrolysis reactions that lower the pH. Consequently, for future thermoelectric applications in volcanic environments, only copper protected with some type of organic coatings should be used. Otherwise, its use is not recommended.

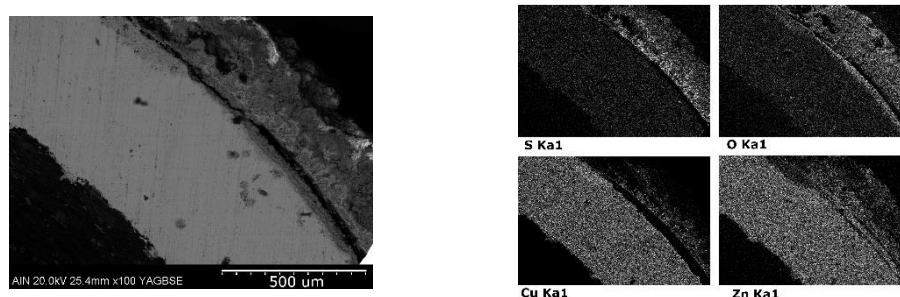
Figure 9 shows the formation of a large amount of oxides formed on the external surface of the brass due to the presence of moisture. The microanalyses carried out indicate that in the intercalary between the metal and the layer of oxides an impoverishment of the zinc has taken place, causing, therefore, a dezincification.

Figure 9. Elemental mapping performed by SEM-EDX in brass sample.

The brass sample has suffered a selective corrosive attack due to the reaction of the zinc with the sulphur-rich compounds in the soil forming mainly ZnS . This dezincification corrosion mechanism, characteristic of brass alloys with zinc contents higher than 30%, was observed by the Greeks on brass buried in Roman times in the 10th century.

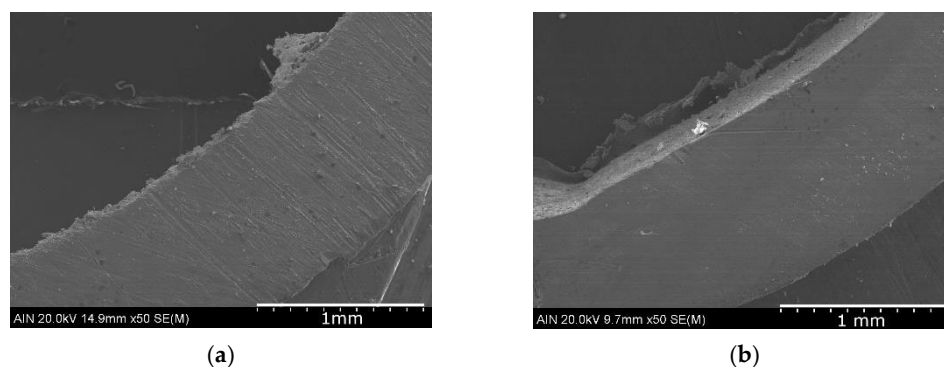
Finally, Figure 10 shows how a dense and adherent layer has formed on the inner surface of the AISI 304 and AISI 316 stainless steel samples. The external part has not experienced corrosion while the internal one has formed a layer of oxides, which is more intense in AISI 316.

Figure 10. SEM images of (a) AISI 304 stainless steel, (b) AISI 316 stainless steel.

Due to the formation of a passive layer, stainless steel samples have shown good corrosion performance in this acidic ambient so they are proposed as candidates for thermoelectric devices.

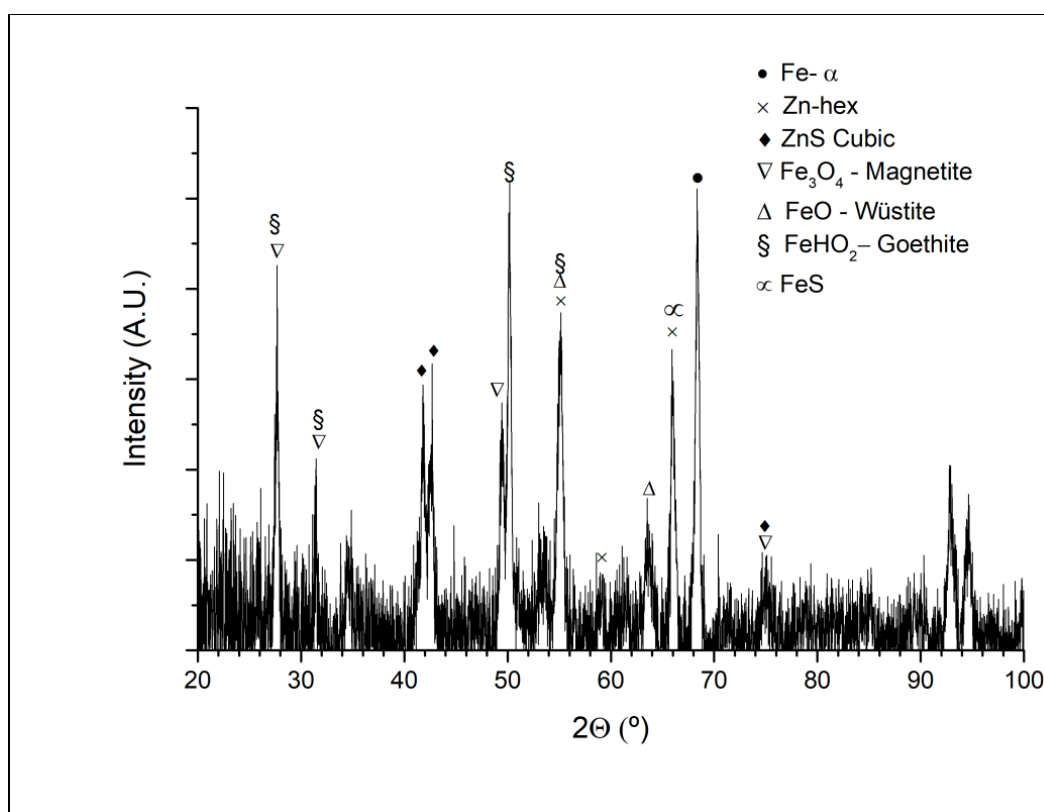
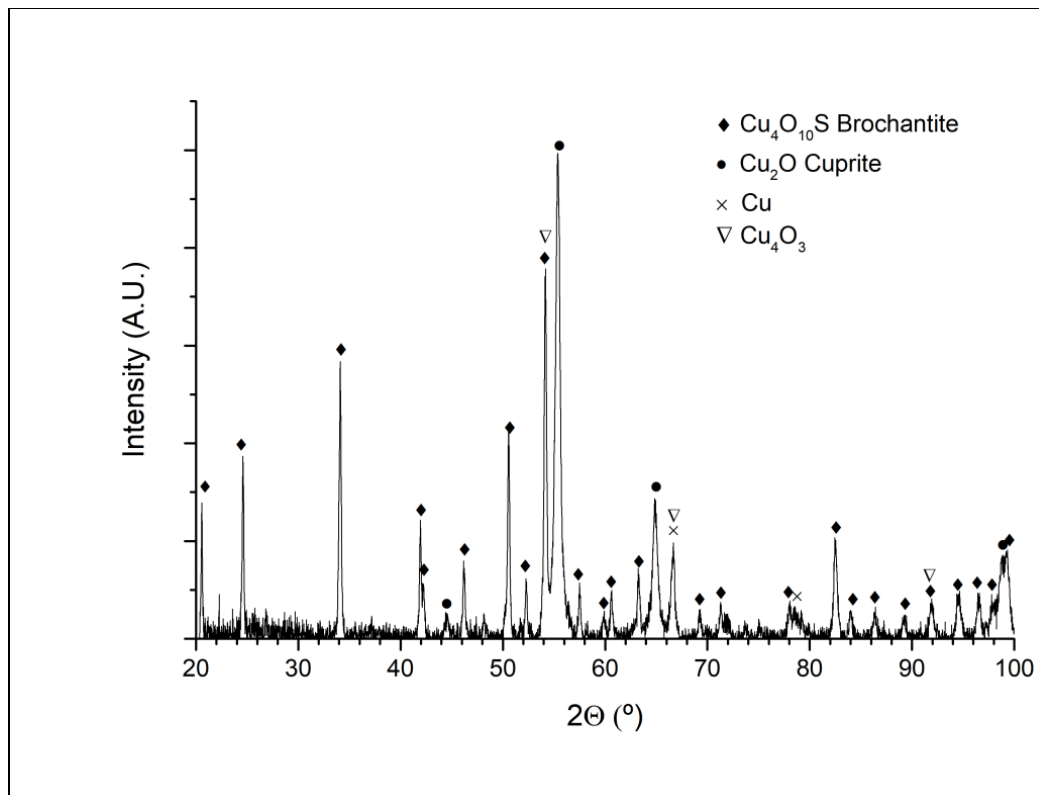
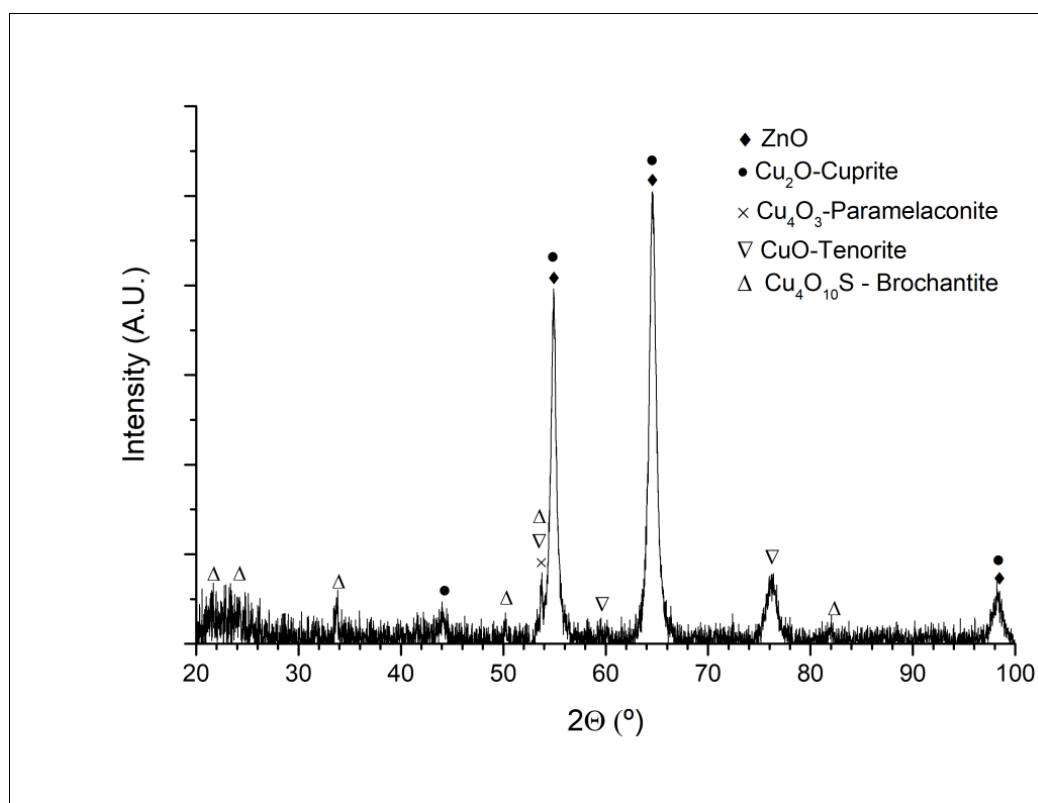
X-ray diffraction is the last analysis that was performed. Figure 11 displays the diffractograms obtained from the corrosion products removed from the galvanized steel, copper, and brass samples. Diffractograms of anodized aluminum and stainless steels were not obtained since insufficient corrosion products had been formed.

In the diffractogram of the galvanized steel a mixture of zinc corrosion products consequence of zinc and iron corrosion have been identified as FeO , Fe_3O_4 , ZnS , and FeS_2 .

On its behalf, the corrosion products identified in the copper sample have been mainly the cuprite (Cu_2O) and paramelaconite (Cu_4O_3) and to a minor degree the brochantite ($\text{Cu}_4\text{O}_{10}\text{S}$).

Finally, in the corrosion products of brass, it has been mainly detected ZnO and to a lower proportion cuprite and tenorite.

Figure 11. XRD diffractogram of (a) galvanized steel, (b) copper, (c) and brass.
