Study of the degradation of heat exchanger materials in the acidic environment of Teide National Park

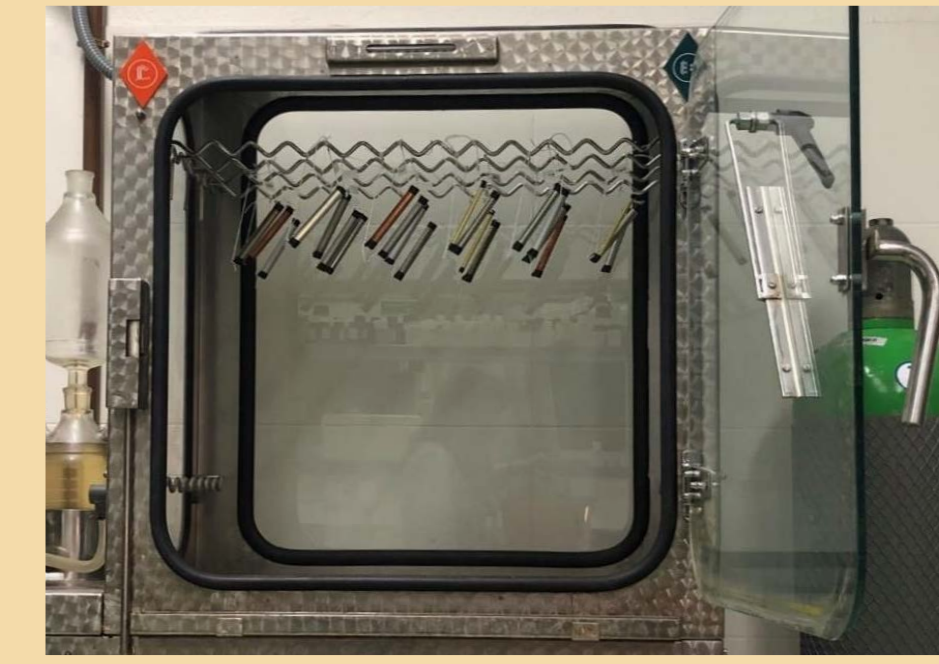
KESTERNICH

- **0.2 L SO₂(g) and 100% humidity, 10 cycles.**
- After Kesternich test, weight loss, MO, SEM and XRD analyses have been performed.
- **In Teide volcano since December 2018**
- Photographs have been taken periodically.
